Groove Mechanical Connectors Show Better Erosion/Corrosion Resistance with Copper Piping than Sweated Joints

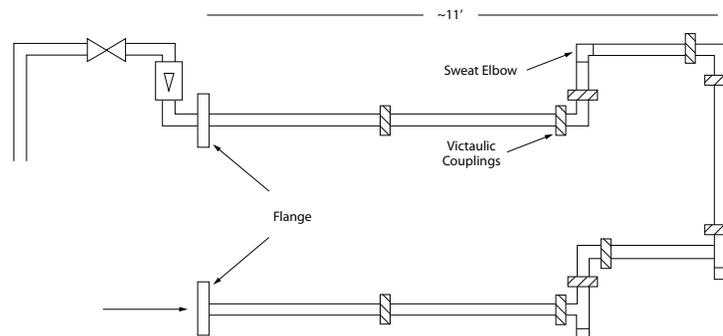
Figure 1

Schematic view of the piping test loops: (top) seawater and (bottom) freshwater.

In order to evaluate any effects this rolled-in groove may have on the erosion/corrosion behavior of copper piping, two identically configured test systems utilizing actual piping components were set up at the LaQue Center at Wrightsville Beach, NC. These systems, shown in Figure 1, included straight couplings, 90° elbows, and branch tee runs using 2 1/2" L grade copper pipe. Lead solder joints were also included to provide control data.

The first system was operated at 6 ft./sec. with once-through ambient temperature natural seawater to provide short term indications of any problem areas. Considering the aggressiveness of this environment, attack at any substantial flow disturbance was anticipated and would quickly identify any problem areas. This system was set up outdoors on the bulkhead adjacent to Banks Channel and operated for 60 days with an interim inspection conducted at 30 days.

The second system was operated with potable water at 150°F/ +66°C. The potable water was taken from the Wrightsville Beach municipal water system and fed to the test system at a rate to allow for a complete exchange of water every 24 hours. Flow through the test piping was maintained at 6 ft./sec. to duplicate the highest velocity condition anticipated in actual service. The test duration for this system was scheduled for six months with monthly inspections.

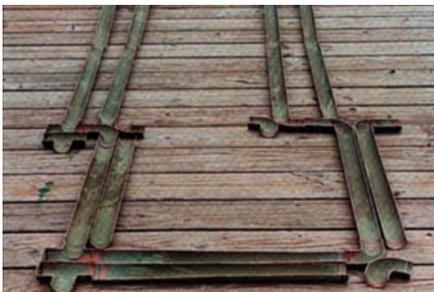
Figure 4

Overall view of the seawater test loop after cross-sectioning.

Following the 30 day inspection, the system was assembled and operated for another 30 days. After 60 days, testing was terminated according to schedule and the system was completely disassembled and split longitudinally to allow more detailed visual inspections, photographing, and measurements of attack. Figures 6 – 11 show the appearance of the test sections after the operation in natural seawater for 60 days.

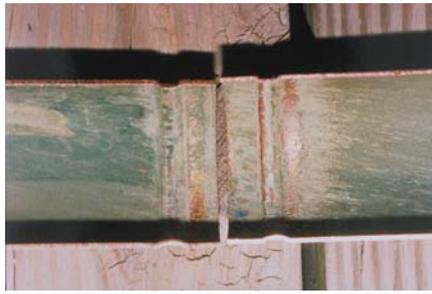
Figure 5

Appearance at roll grooved area after 60 days in natural seawater (flow - left to right).

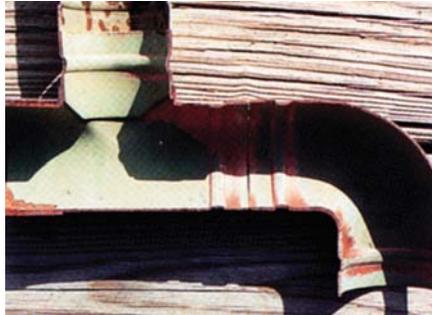
Figure 6

Appearance of the inside of the tee/elbow combination after 60 days in natural seawater (flow - left to right).

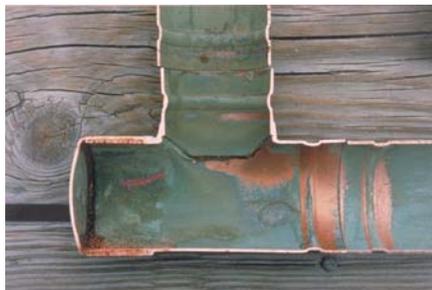
Figure 7

Appearance at roll grooved tee after 60 days in natural seawater (flow - left to right).

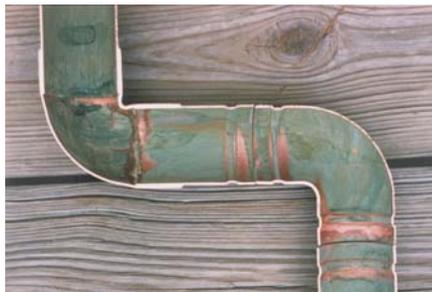
Figure 8

Appearance of sweat elbow and roll grooved elbow after 60 days in natural seawater (flow - left to right).

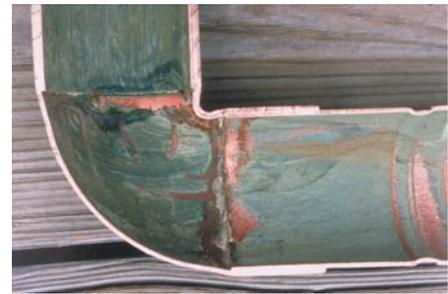
Figure 9

Only one site of measurable localized attack, as shown in Figure 9, was found. This localized erosion corrosion, measuring 10 to 15 mils in depth, resulted from excess solder deposits left on the inside diameter from the sweating operation.

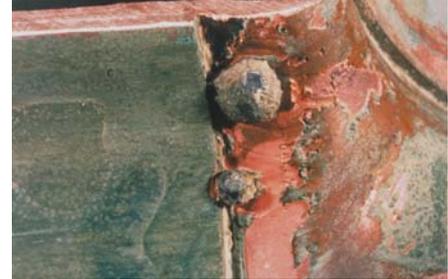
Figure 10

Appearance of copper pipe at upstream roll groove after 30 days in potable water at 150°F/66°C.

As in the seawater test system, the potable water system was partially disassembled and inspected after 30 days of testing. Photographs taken during this inspection are shown in Figures 10 – 11. This inspection indicated that there was no visible attack and that an adherent corrosion product film was in place.

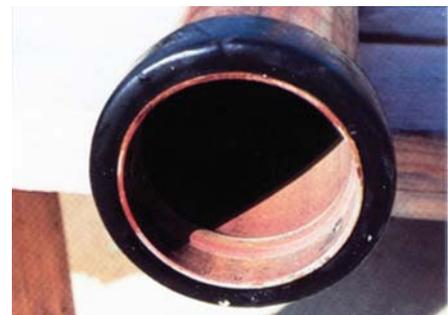
Figure 11

Appearance of copper pipe at upstream roll groove after 30 days in potable water at 150°F/66°C.

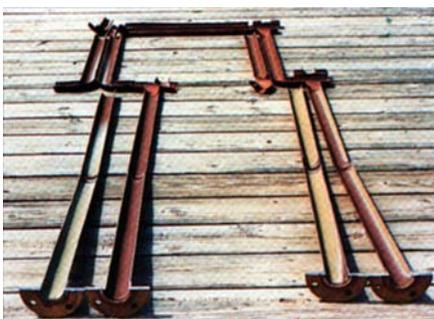
Figure 15

Overall appearance after six months operation at 6 ft./sec. in 150°F/+66°C potable water.

At the conclusion of the six month test period, the system was shut down, disassembled, and the test sections were split longitudinally. The overall appearance of the inside diameter of the system is shown in Figure 15. Close-up photographs of the higher turbulence areas are shown in Figures 16 – 19. As can be seen in these photographs, there are no signs of any attack associated with the roll grooves.

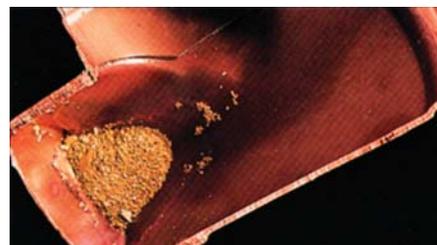
Figure 20

The fully developed corrosion product film was affected at only one place. This location, as shown in Figure 20, was at the bottom of the sweated cap on one of the tees. This area was the low point within the test piping section of the system and apparently the highly abrasive carbonate material precipitated from the potable water collected in this location was continually swirled. This swirling action kept the copper from developing its naturally protective film (or continually abraded it away) and caused the accelerated corrosion observed here. The carbonate material found in this system is typical of heated Wrightsville Beach municipal water and is due to the high (650 - 750 ppm) total dissolved solids content. The depth of this attack is approximately five mils.

Appearance of attack caused by carbonate material in bottom of sweated tee cap (depth of attack five mils).

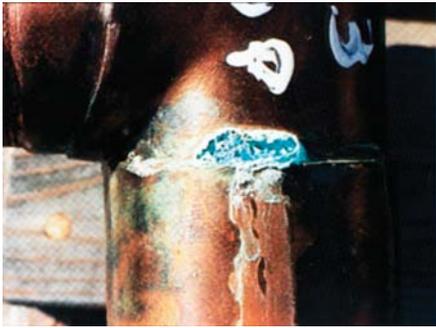
Figure 21

Appearance of corrosion product buildup on exterior surface of sweated joint after approximately six months.

Upon inspection of the outer surfaces of this system, there was only one location that displayed signs of localized corrosion. This attack, shown in Figure 21, was apparently caused by the acid based flux used in the sweating operation.
